**Flood Control Project Maintenance
Levee Inspections**
LMA District Cover Sheet
Spring 2018 Levee Inspection Results

Reclamation District No. 1000 Natomas

Spring 2018 Levee Inspection Results

Waterway			Bank	Unit Miles
Unit No. 01 Sacramento River			Left	18.28
	Spring (March - May)	Summer (June - August)	(September - November) Fall	Winter (December - February)
Unit Maintenance Rating (Fall Only)				
Date of Inspection	3/14/2018 - 3/14/2018			
DWR Inspector	Sterling York			
Accompanied By	Don Caldwell RD1000

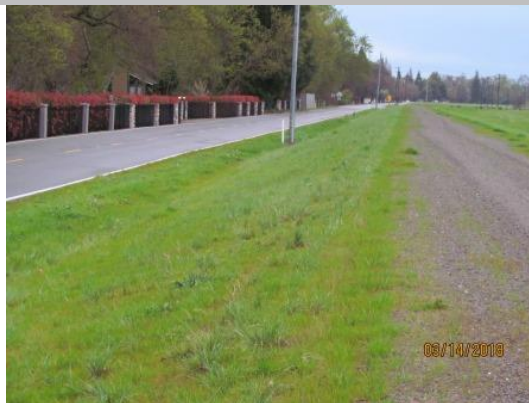
Photo 1 of 1 : SP_2018_RD1000_31_7_20180319_00044.jpg

View looking upstream waterside of the well maintained annual vegetation, Spring 2018.

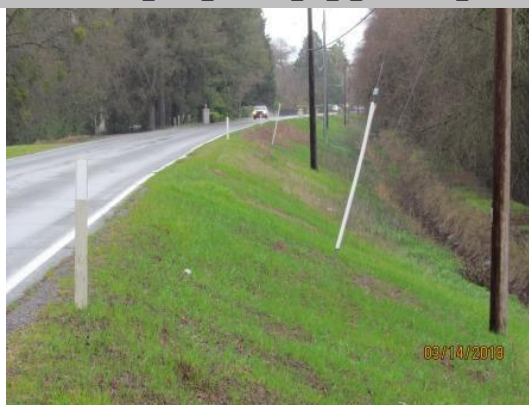
Photo 1 of 2 : SP_2018_RD1000_31_6_20180320_00047.jpg

View looking upstream Landside at Levee Mile 15.65 of the well maintained annual vegetation, Spring 2018.

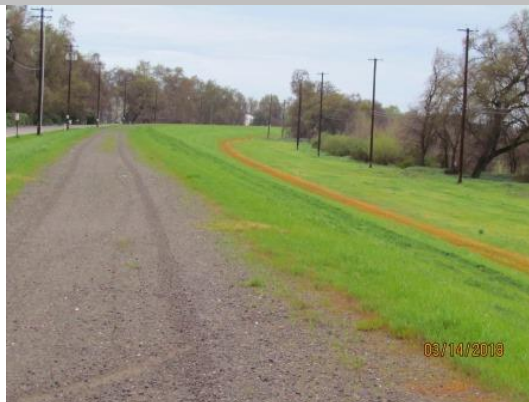
Photo 2 of 2 : SP_2018_RD1000_31_6_20180320_00045.jpg

View looking upstream Landside at Levee Mile 7.90 of the well maintained annual vegetation, Spring 2018.

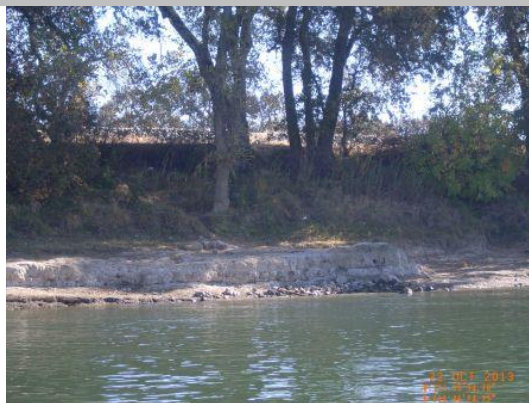
Photo 1 of 1 : SP_2018_RD1000_31_3_20180302_00002.jpg

LM Start	0.48	Rating **	M	Issue No.	3
LM End	0.61	Issue Type +	Ma	Location *	WS
Category	Supplemental			GPS Latitude/Longitude	
				Start	End
Item	2015 USACE Erosion Survey, DRAFT			38.774507 °	38.772921 °
				-121.598865 °	-121.597788 °
DWR ID	DWR_RD1000_01_s_2016_3				
Comment Code					
Inspector Comment					
1997 - Very cohesive toe. 2005 - Site was staked and rock was stockpiled along the top of the bank. 2010 - New adjacent levee under construction. 2011 - New animal burrow. 2015: No observed changes. [2015 Site ID: SAC_78-3_L]

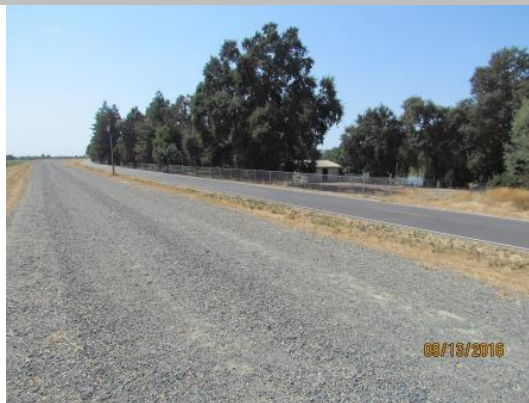
Photo 1 of 1 : SP_2018_RD1000_31_136_20180302_00042.jpg

View of an encroachment, 'Fence'. Fall 2016.

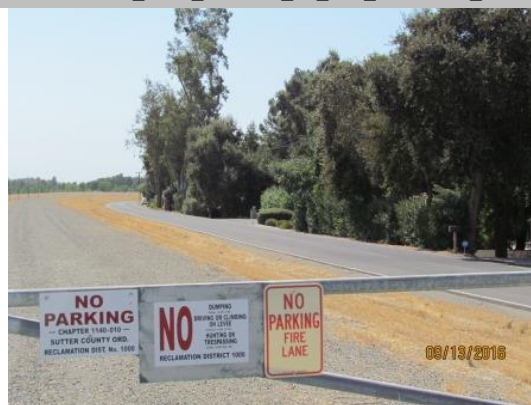
Photo 1 of 1 : SP_2018_RD1000_31_133_20180302_00041.jpg

Typical Garden Hwy 'Landscaping'. Fall 2016.

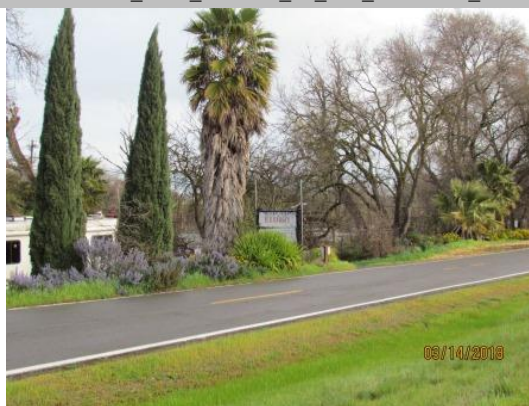
Photo 1 of 1 : SP_2018_RD1000_31_121_20180320_00050.jpg

View looking upstream waterside of landscape vegetation that is blocking access and visibility to the levee, Spring 2018.

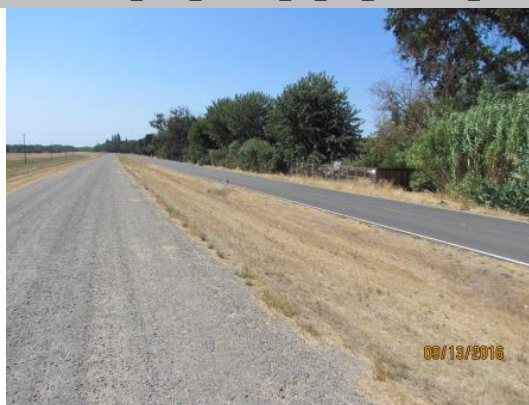
Photo 1 of 1 : SP_2018_RD1000_31_120_20180302_00040.jpg

Typical vegetation along the waterside in front of residences. Fall 2016.

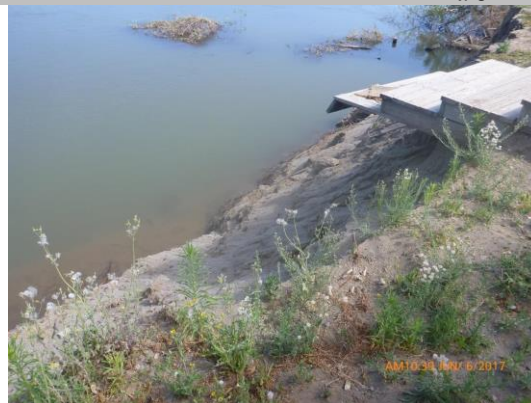
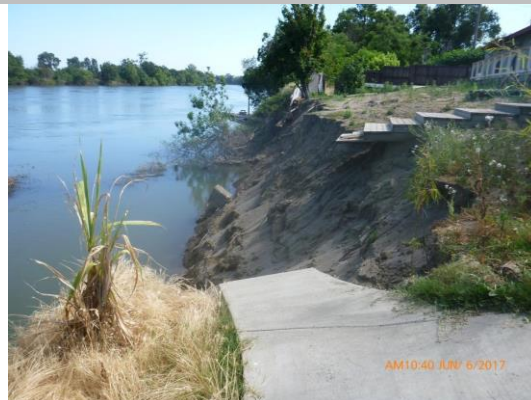
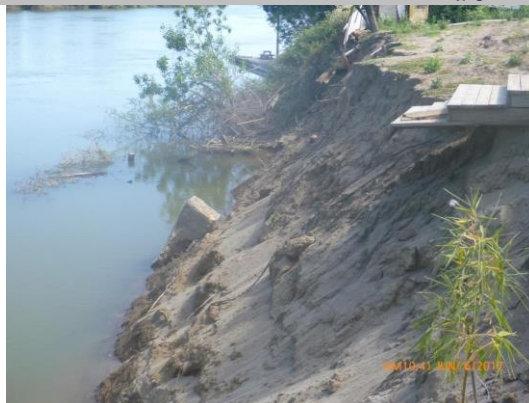
LM Start	5.21	Rating **	A/W	Issue No.	4	
LM End	5.21	Issue Type +	Ma	Location *		
Category	Supplemental			GPS Latitude/Longitude		
				Start	End	
Item	2017 Storm Damage			38.710830 °	38.710830 °	
				-121.611100 °	-121.611100 °	
DWR ID	DWR_RD1000_01_f_2017_4					
Comment Code						
Inspector Comment						
Levee Evaluation Comments						
Description:						
Site ID No:45						
Site Designation:LMA-12						
Repair Type: Erosion						
Rating:Area of Concern						
Field Date:6/6/2017						
Notes: private residence

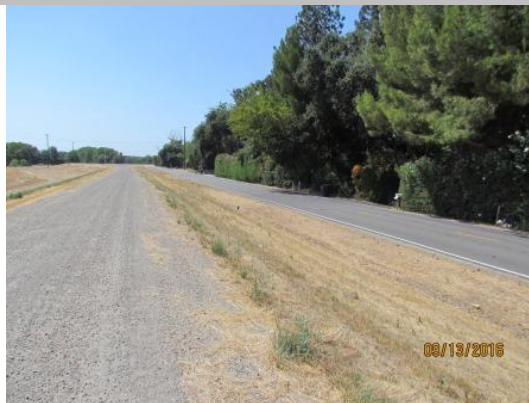
Photo 1 of 1 : SP_2018_RD1000_31_118_20180302_00039.jpg

This photo was taken from the crown facing downstream looking down the waterward levee slope at unacceptable landscaping. Fall 2016.

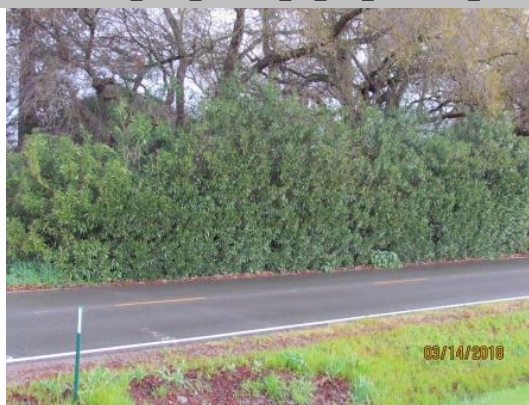
Photo 1 of 1 : SP_2018_RD1000_31_116_20180322_00051.jpg

View looking at waterside landscape vegetation that is blocking access and visibility to the levee, Spring 2018.

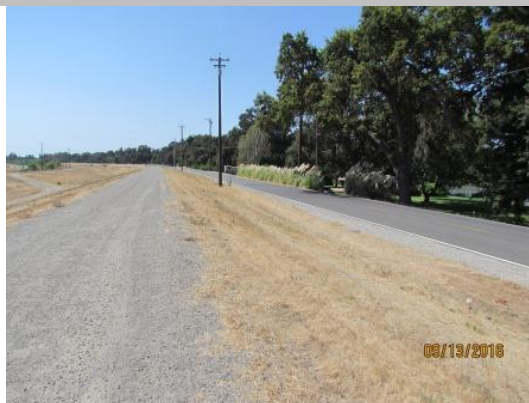
Photo 1 of 1 : SP_2018_RD1000_31_111_20180302_00038.jpg

This photo was taken from the crown facing downstream looking down the waterward levee slope at unacceptable landscaping. Fall 2016.

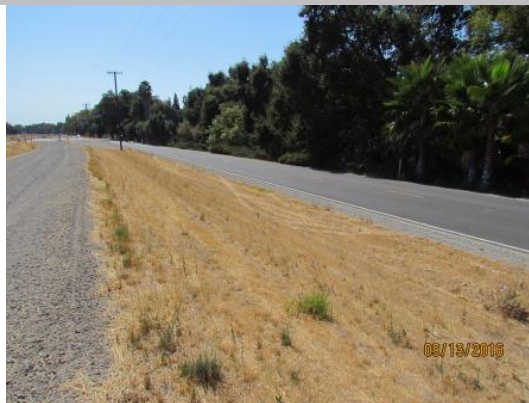
Photo 1 of 1 : SP_2018_RD1000_31_63_20180302_00027.jpg

This photo was taken facing the waterside of the levee looking downstream of typical vegetation in front of residence. Fall 2016.

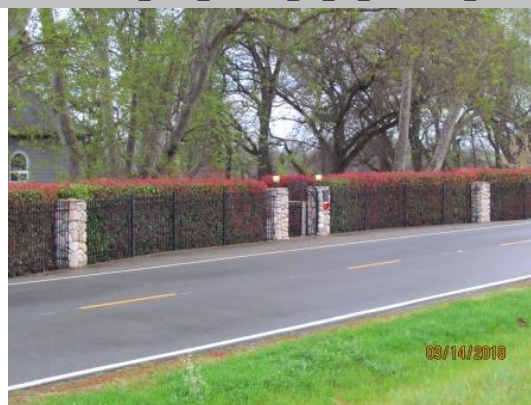
Photo 1 of 1 : SP_2018_RD1000_31_95_20180322_00053.jpg

View looking at waterside landscape vegetation that is blocking access and visibility to the levee, Spring 2018.

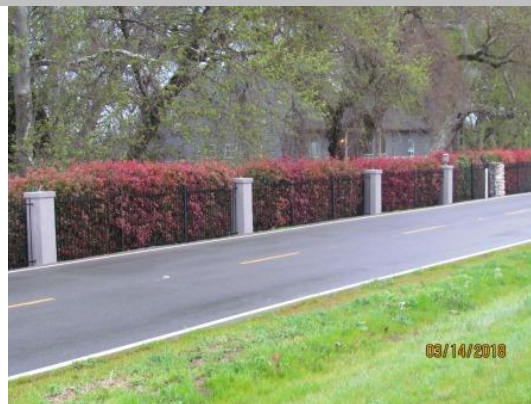
Photo 1 of 1 : SP_2018_RD1000_31_94_20180322_00054.jpg

View looking at waterside landscape vegetation that is blocking access and visibility to the levee, Spring 2018.

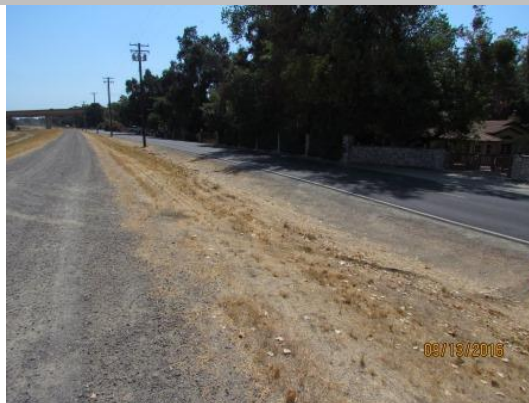
Photo 1 of 1 : SP_2018_RD1000_31_90_20180302_00034.jpg

This photo was taken from the crown facing downstream looking downstream. Landowner maintained vegetation completely block visibility of or access to the levee. Fall 2016.

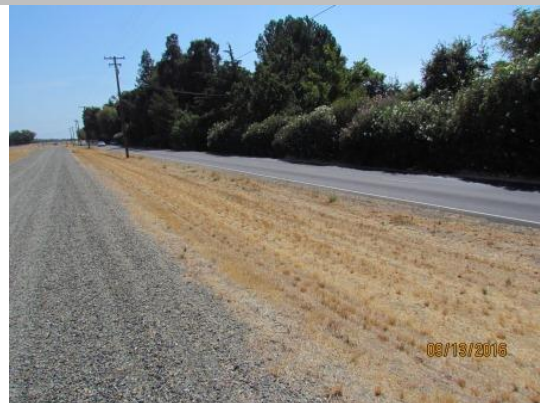
Photo 1 of 1 : SP_2018_RD1000_31_82_20180302_00033.jpg

This photo was taken from the crown facing downstream waterside levee slope at unacceptable landscaping. Fall 2016.

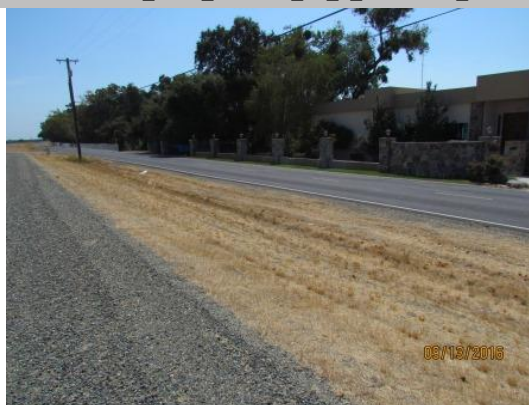
Photo 1 of 1 : SP_2018_RD1000_31_2_20180302_00001.jpg

This photo was taken during Fall 2015 from the crown facing downstream on the waterward levee slope at an enforcement issue with this fence, per the NOV all panels of the fence are to be removed. The owner has remove some of the panels between the post. Spring 2017.

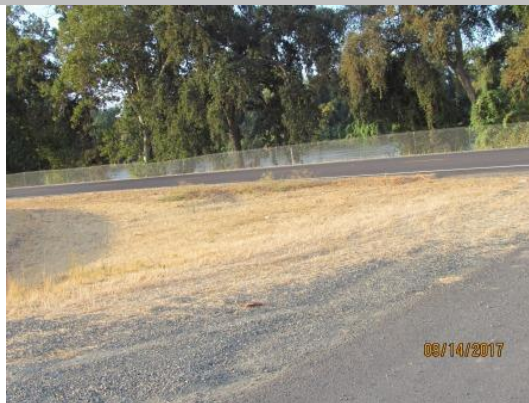
Photo 1 of 1 : SP_2018_RD1000_31_10_20180302_00009.jpg

View on waterside of a non-permitted fence, Fall 2017.

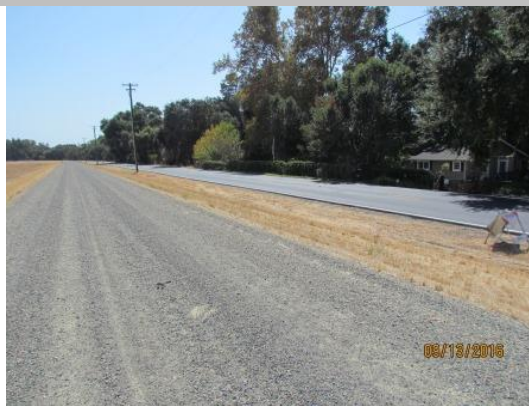
Photo 1 of 1 : SP_2018_RD1000_31_74_20180302_00031.jpg

This photo was taken from the crown facing downstream looking down the waterward levee slope at unacceptable landscaping. Fall 2016.

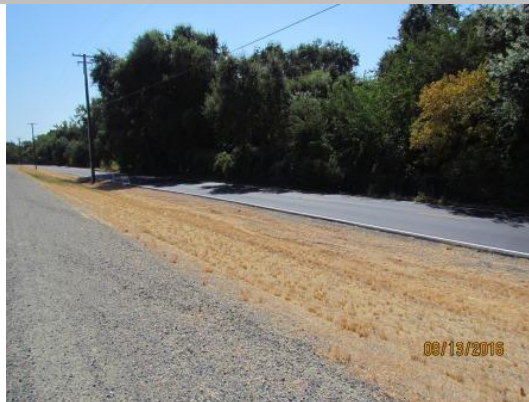
Photo 1 of 1 : SP_2018_RD1000_31_73_20180302_00030.jpg

This photo was taken from the crown facing downstream looking down the waterward levee slope at unacceptable landscaping. Fall 2016.

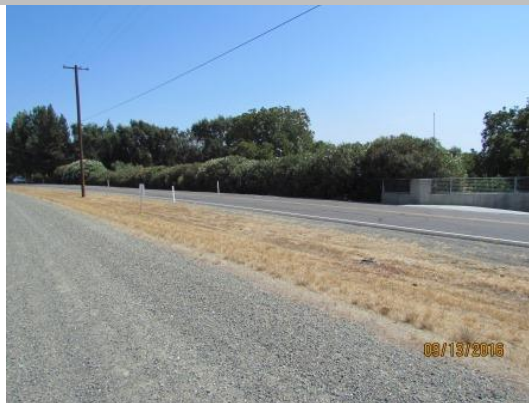
Photo 1 of 1 : SP_2018_RD1000_31_70_20180302_00029.jpg

This photo was taken from the crown facing downstream looking down the waterward levee slope at unacceptable landscaping. Fall 2016.

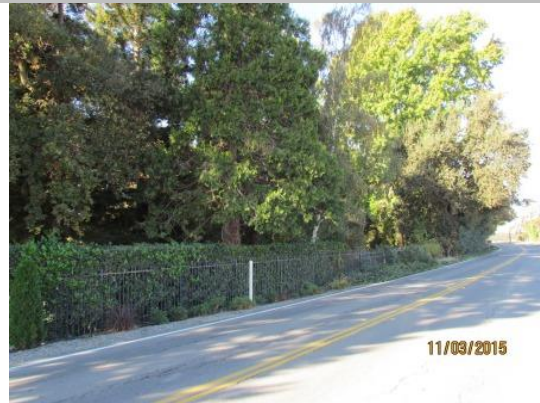
Photo 1 of 1 : SP_2018_RD1000_31_66_20180302_00028.jpg

View of the landscaping on the waterside levee slope.

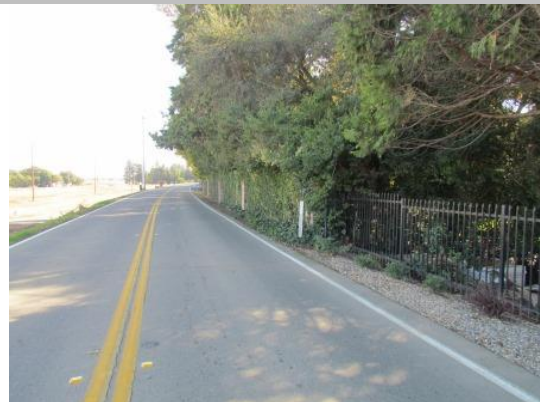
Photo 1 of 1 : SP_2018_RD1000_31_62_20180302_00026.jpg

This photo was taken from the crown facing downstream looking down the waterward levee slope at unacceptable landscaping. Fall 2014.

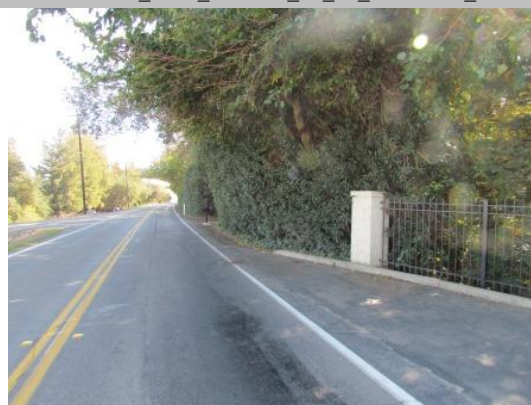
Photo 1 of 1 : SP_2018_RD1000_31_60_20180302_00025.jpg

This photo was taken from the crown facing downstream looking down the waterward levee slope at unacceptable landscaping. Fall 2014.

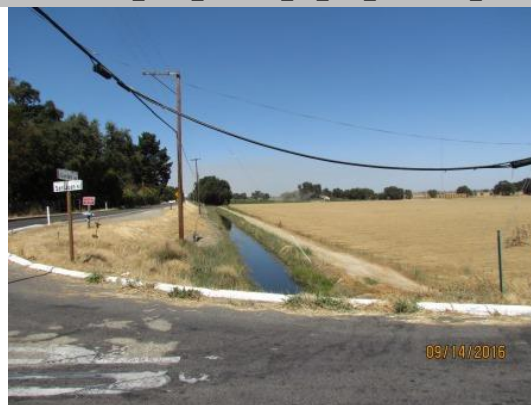
Photo 1 of 1 : SP_2018_RD1000_31_101_20180302_00035.jpg

View looking upstream at ditch on landside toe.

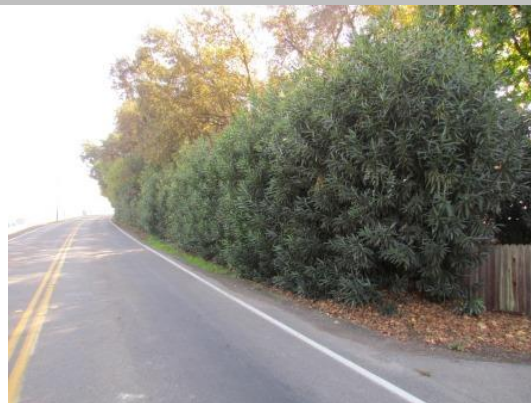
Photo 1 of 1 : SP_2018_RD1000_31_58_20180302_00024.jpg

This photo was taken from the crown facing downstream looking down the waterward levee slope at unacceptable landscaping. Fall 2014.

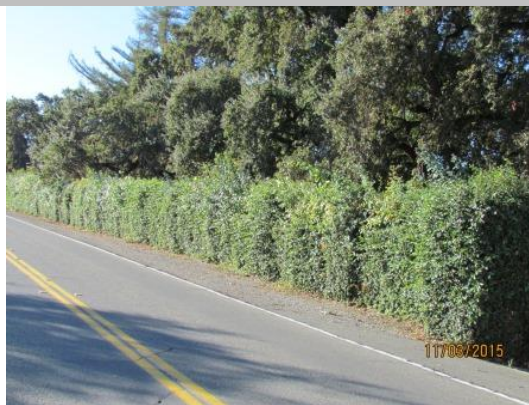
Photo 1 of 1 : SP_2018_RD1000_31_51_20180302_00022.jpg

View of the landscaping on the waterside levee slope.

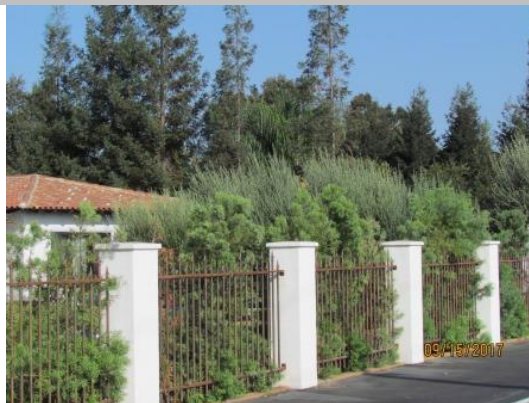
Photo 1 of 1 : SP_2018_RD1000_31_46_20180302_00021.jpg

View on waterside looking upstream of where the vegetation covers the front of the fence, Fall 2017.

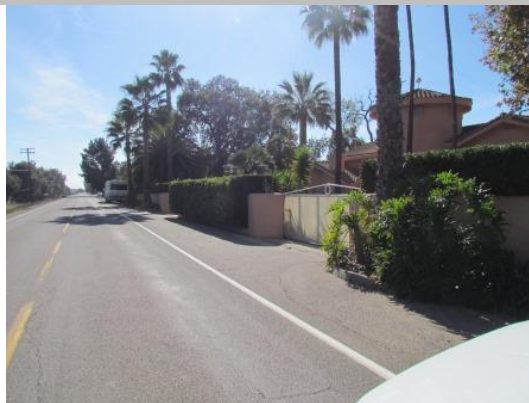
Photo 1 of 1 : SP_2018_RD1000_31_43_20180302_00020.jpg

This photo was taken from the crown facing downstream looking down the waterward levee slope at an unacceptable fence. Fall 2014.

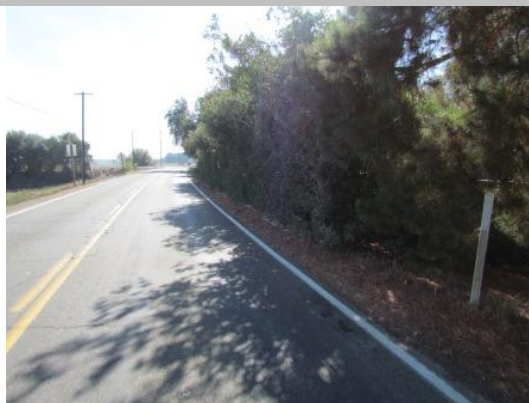
Photo 1 of 1 : SP_2018_RD1000_31_42_20180302_00019.jpg

This photo was taken from the crown facing downstream looking down the waterward levee slope at unacceptable landscaping. Fall 2014.

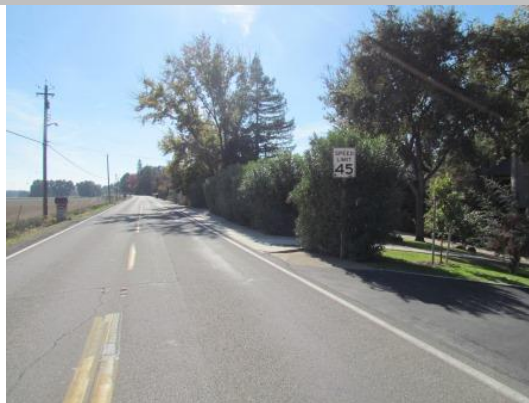
Photo 1 of 1 : SP_2018_RD1000_31_40_20180302_00018.jpg

This photo was taken from the crown facing downstream looking down the waterward levee slope at unacceptable landscaping. Fall 2014.

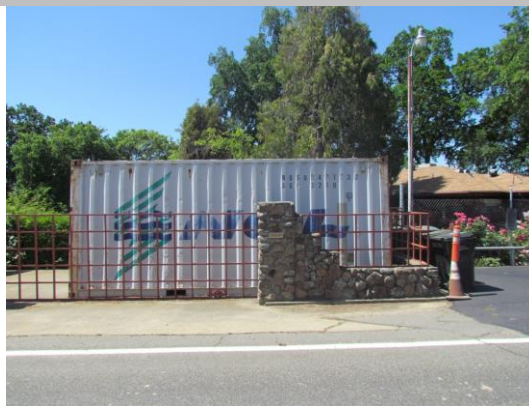
Photo 1 of 1 : SP_2018_RD1000_31_53_20180302_00023.jpg

View of storage container from the landside of the crown facing the waterside of the levee.

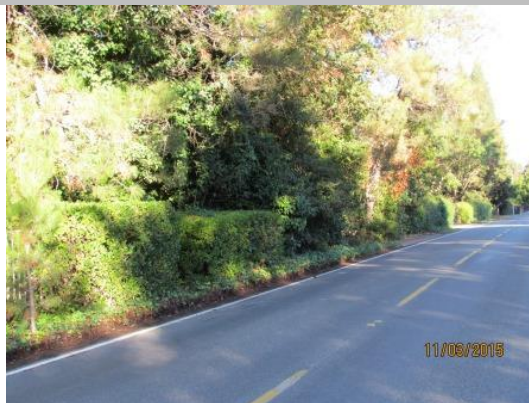
Photo 1 of 1 : SP_2018_RD1000_31_35_20180302_00017.jpg

View of the landscaping on the waterside levee slope.

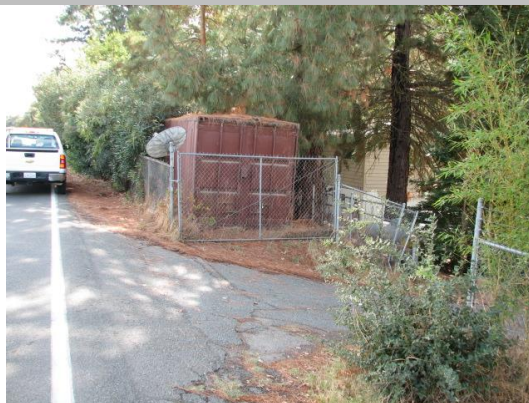
Photo 1 of 1 : SP_2018_RD1000_31_76_20180302_00032.jpg

Cargo container on levee shoulder, the property appears to be on fill material.

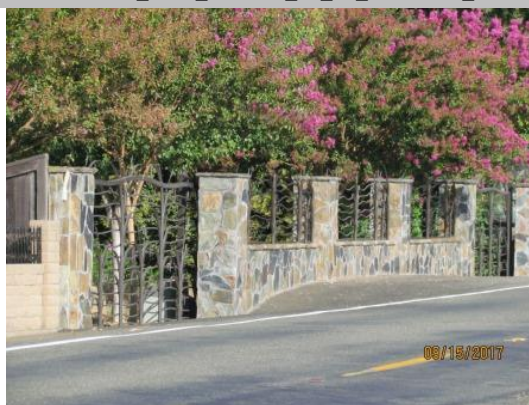
Photo 1 of 1 : SP_2018_RD1000_31_32_20180302_00016.jpg

View on waterside looking upstream of a rock and wrought iron fence that partially blocks visibility and access, Fall 2017.

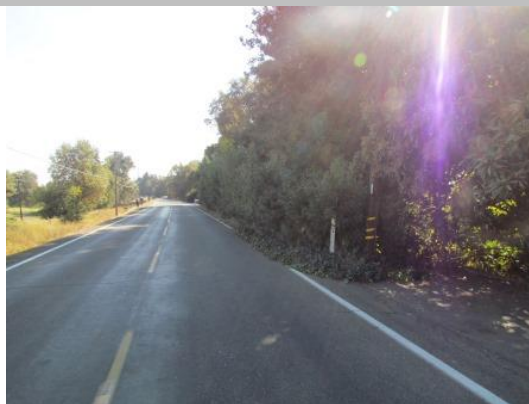
Photo 1 of 1 : SP_2018_RD1000_31_31_20180302_00015.jpg

This photo was taken from the crown facing downstream looking down the waterward levee slope at unacceptable landscaping. Fall 2014.

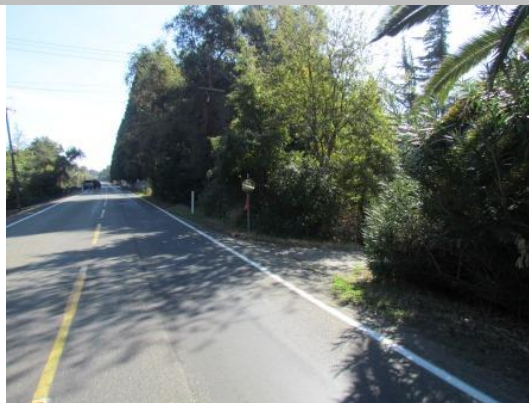
Photo 1 of 1 : SP_2018_RD1000_31_30_20180302_00014.jpg

This photo was taken from the crown facing down stream looking down the waterward levee slope at unacceptable landscaping. Fall 2014.

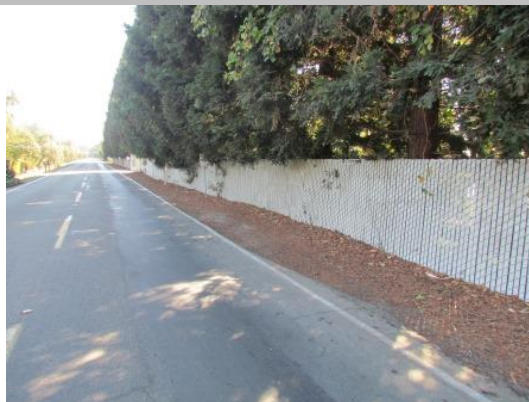
Photo 1 of 1 : SP_2018_RD1000_31_29_20180302_00013.jpg

This photo was taken from the crown facing downstream looking down the waterward levee slope at an unacceptable fence. Fall 2014.

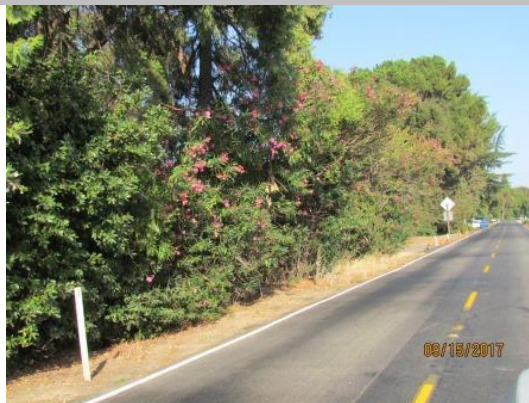
Photo 1 of 1 : SP_2018_RD1000_31_19_20180302_00012.jpg

View on waterside looking upstream of property covered by Oleander Bushes, Fall 2017.

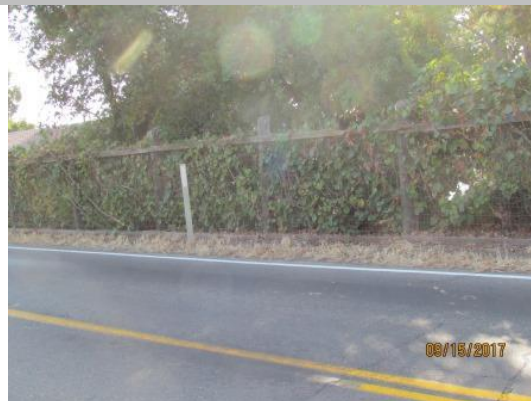
Photo 1 of 1 : SP_2018_RD1000_31_14_20180302_00011.jpg

View on waterside looking across at the fence covered by vegetation, Fall 2017.

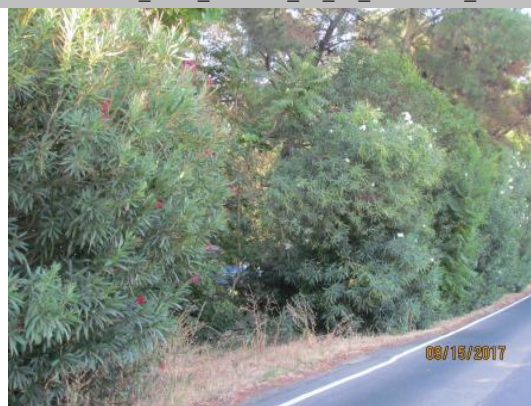
Photo 1 of 1 : SP_2018_RD1000_31_13_20180302_00010.jpg

View of fence covered by Oleander Bushes, Fall 2017.

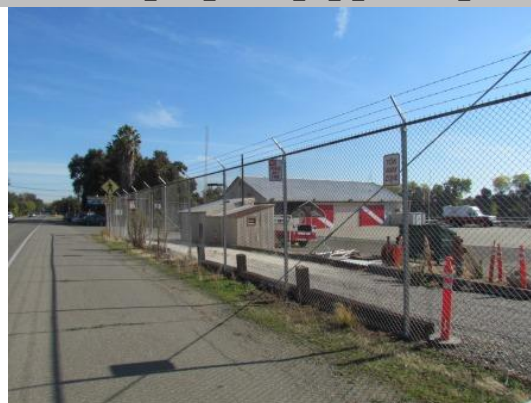
Photo 1 of 1 : SP_2018_RD1000_31_8_20180302_00007.jpg

This photo was taken from the crown facing downstream looking down the waterward levee slope at an unacceptable building. Fall 2014.

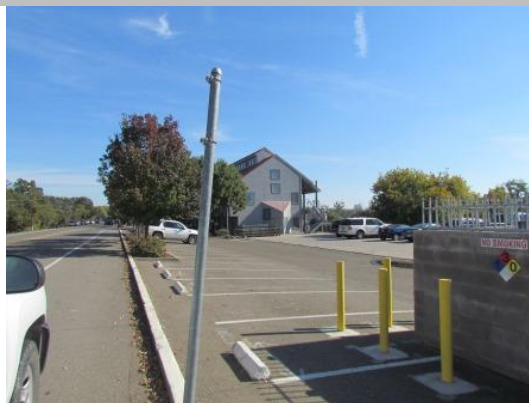
Photo 1 of 1 : SP_2018_RD1000_31_5_20180302_00006.jpg

This photo was taken from the crown facing downstream looking down the waterward levee slope at an unacceptable building. Fall 2014.

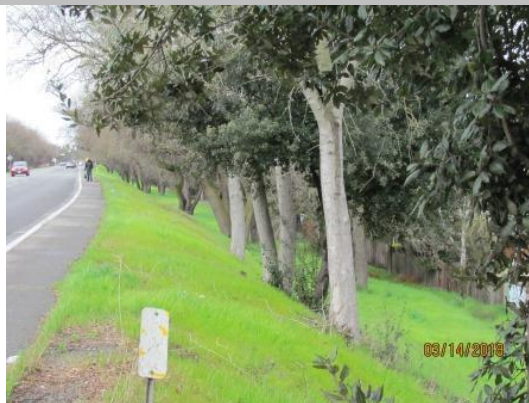
Photo 1 of 1 : SP_2018_RD1000_32_11_20180322_00006.jpg

View looking downstream landside of the well maintained annual vegetation, Spring 2018.

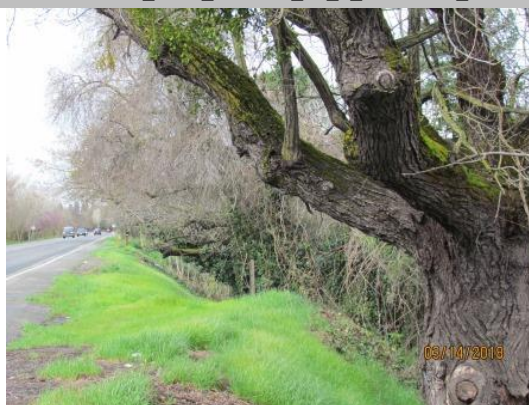
Photo 1 of 2 : SP_2018_RD1000_32_3_20180322_00010.jpg

View looking upstream waterside of trees limbs that have been trimmed, Spring 2018.

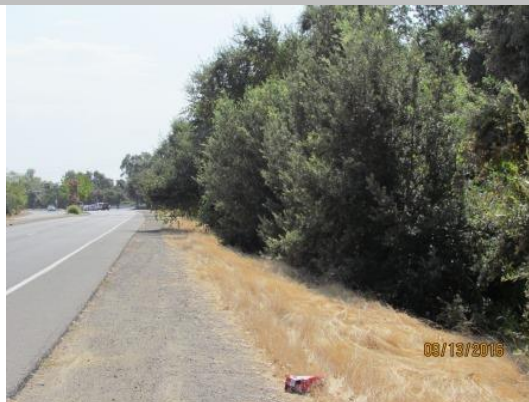
Photo 2 of 2 : SP_2018_RD1000_32_3_20180302_00001.jpg

View looking upstream waterside of trees that need to be trimmed. Fall 2016.

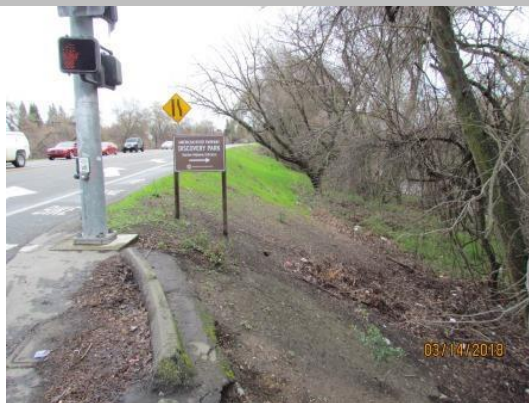
Photo 1 of 1 : SP_2018_RD1000_32_8_20180322_00007.jpg

View looking upstream waterside of the well maintained annual vegetation, Spring 2018.

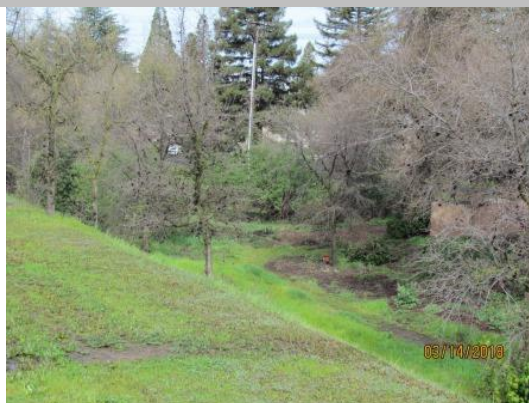
Photo 1 of 1 : SP_2018_RD1000_32_12_20180322_00011.jpg

View of landside looking downstream of trees that have been trimmed for visibility and access, Spring 2018.

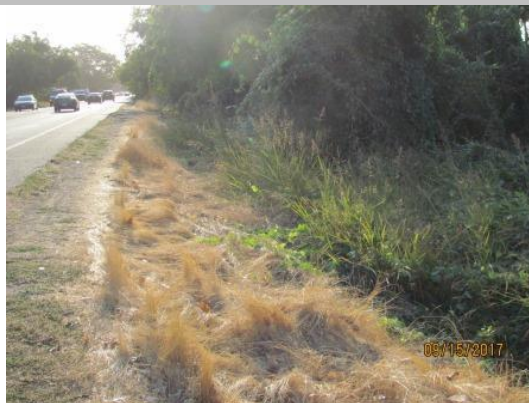
Photo 2 of 2 : SP_2018_RD1000_32_9_20180302_00003.jpg

View of waterside looking upstream of trees that need to be trimmed for visibility and access, Fall 2017.

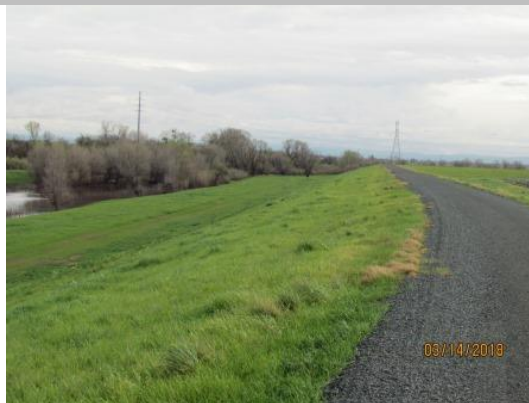
Photo 1 of 2 : SP_2018_RD1000_33_11_20180322_00021.jpg

View looking downstream waterside of the well maintained annual vegetation, Spring 2018.

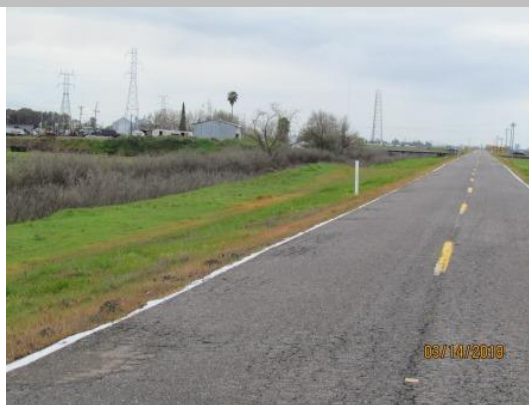
Photo 2 of 2 : SP_2018_RD1000_33_11_20180322_00022.jpg

Another view looking downstream waterside of the well maintained annual vegetation, Spring 2018.

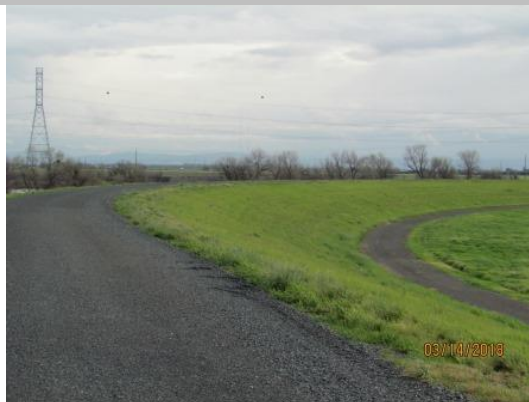
Photo 1 of 2 : SP_2018_RD1000_33_6_20180322_00019.jpg

View looking downstream landside of the well maintained annual vegetation, Spring 2018.

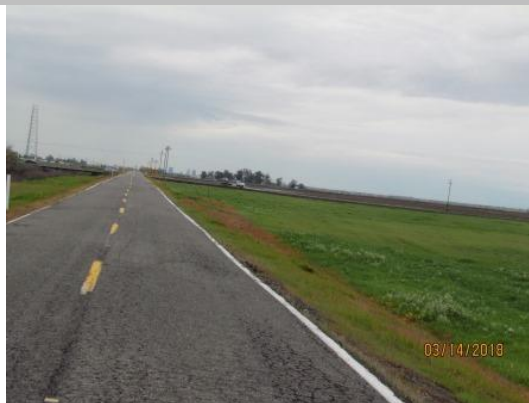
Photo 2 of 2 : SP_2018_RD1000_33_6_20180322_00020.jpg

Another view looking downstream landside of the well maintained annual vegetation, Spring 2018.

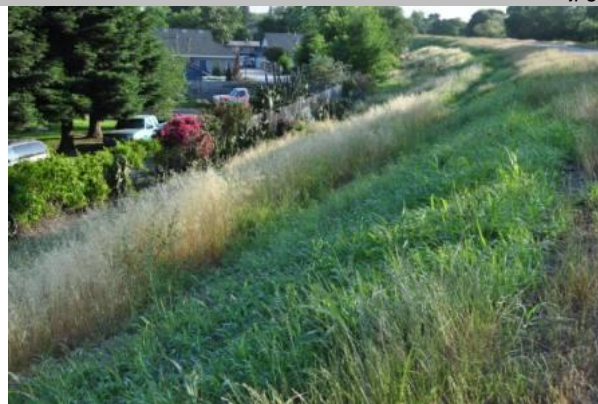
Photo 1 of 2 : SP_2018_RD1000_33_7_20180302_00004.jpg

Fence with vegetation at L/S toe.

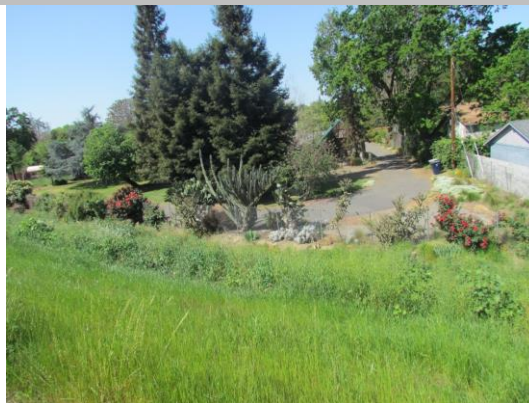
Photo 2 of 2 : SP_2018_RD1000_33_7_20180302_00005.jpg

Taken facing the landside looking downstream.

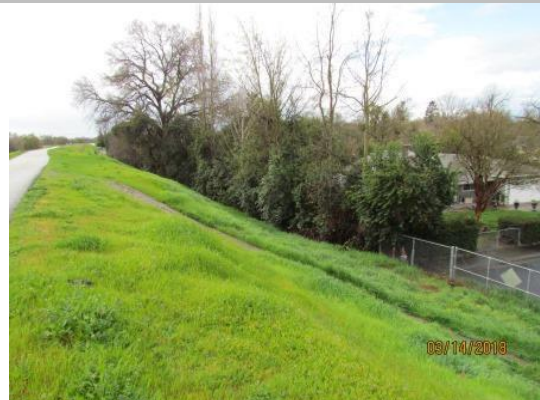
Photo 1 of 1 : SP_2018_RD1000_33_4_20180322_00026.jpg

View looking downstream landside of fence at levee toe, Spring 2018.

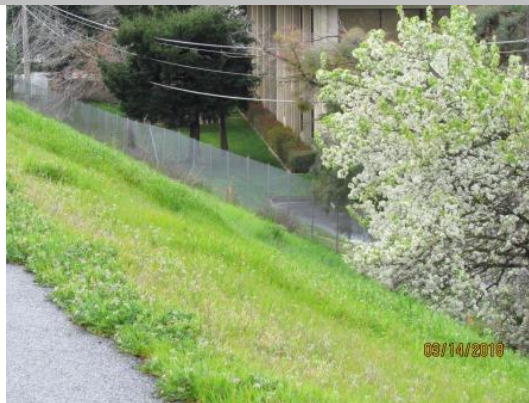
Photo 1 of 1 : SP_2018_RD1000_33_17_20180322_00025.jpg

View looking downstream landside of fence at levee toe, Spring 2018.

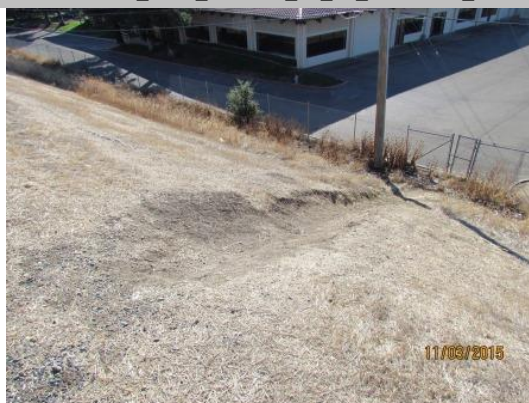
Photo 1 of 1 : SP_2018_RD1000_33_15_20180302_00010.jpg

View of the landside levee slope damaged by foot traffic.

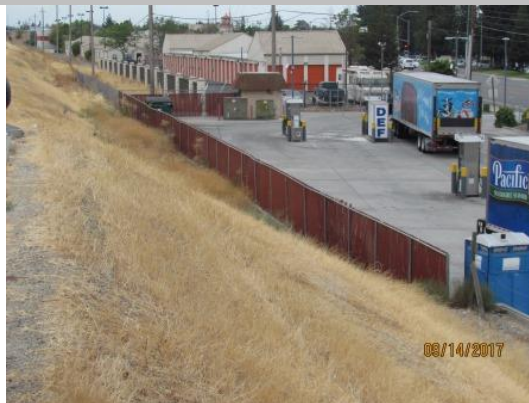
Photo 1 of 1 : SP_2018_RD1000_33_3_20180302_00003.jpg

View looking downstream landside of fence that encroaches at levee toe, Fall 2017.

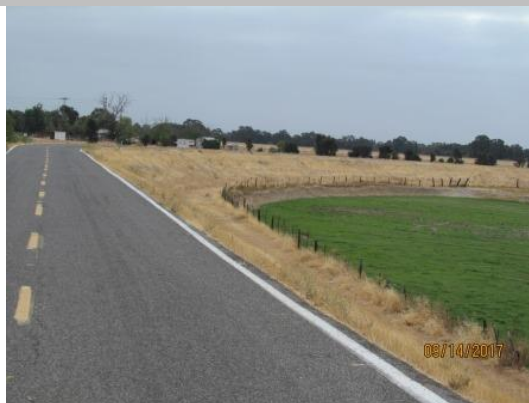
Photo 1 of 1 : SP_2018_RD1000_33_1_20180302_00001.jpg

View taken facing the landside looking downstream at location where there was rodent activity in past years. Rodent holes have been filled and no new activity was observed. Several bait traps at landside levee toe. Fall 2017.

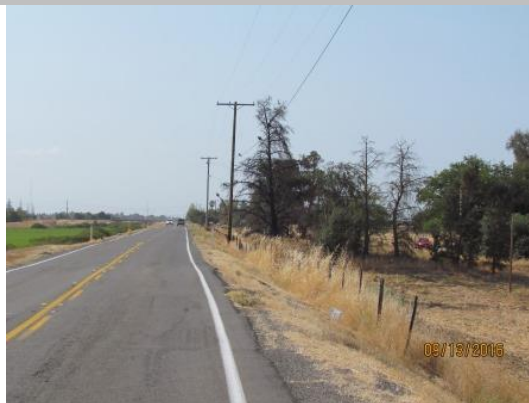
Photo 1 of 1 : SP_2018_RD1000_33_8_20180302_00006.jpg

View of fence on landside levee slope, looking downstream.

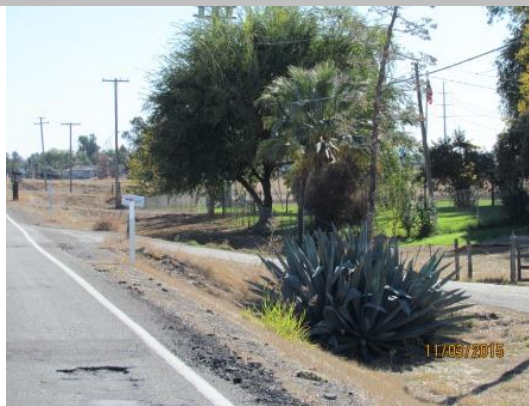
Photo 1 of 1 : SP_2018_RD1000_33_2_20180302_00002.jpg

View of the landscaping at the landside levee toe.

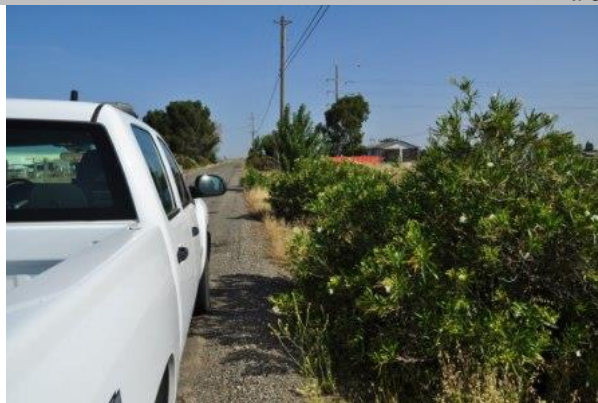
Photo 1 of 1 : SP_2018_RD1000_33_10_20180302_00008.jpg

WS vegetation.

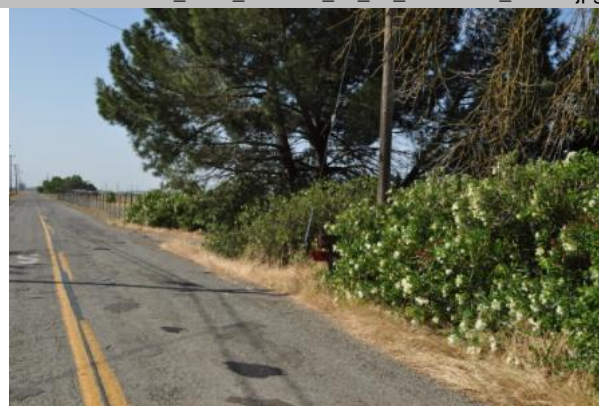
Photo 1 of 1 : SP_2018_RD1000_33_13_20180302_00009.jpg

LS landscaping.

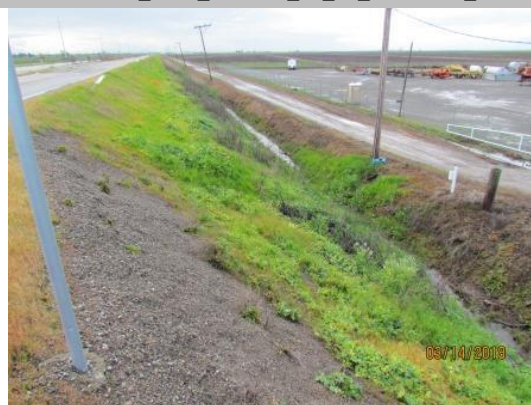
View of landside ditch at toe of levee, looking downstream, Spring 2018.

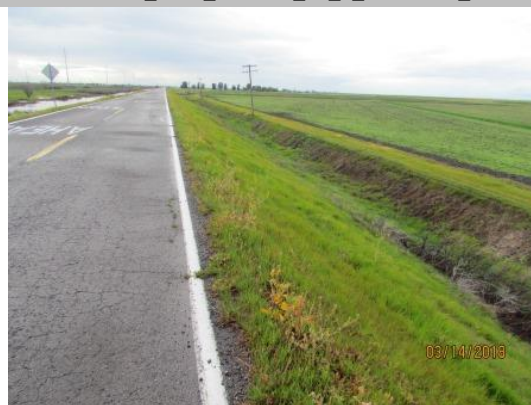
View looking downstream landside at an Ag ditch at the toe, Spring 2018.

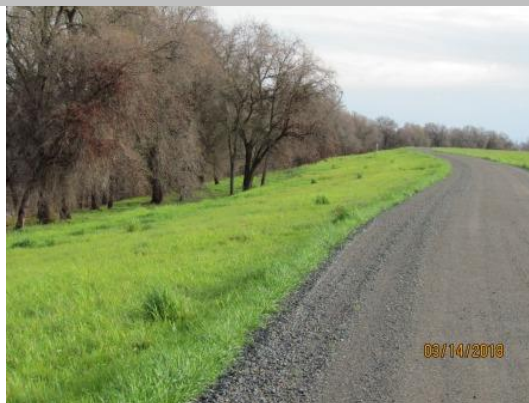
View looking upstream waterside of the well maintained annual vegetation, Spring 2018.
